**LABORATORY MEASUREMENT OF
THE REDUCTION OF
TRANSMITTED IMPACT SOUND OF
UNDERLAY
(ACCORDING TO ISO 10140-3)**

**LABORATORY MEASUREMENT OF THE
REDUCTION OF TRANSMITTED IMPACT
SOUND BY FLOOR COVERINGS ON A
STANDARD FLOOR.**

Reduction of impact sound pressure level according to ISO 10140-3
Laboratory measurements of the reduction of transmitted impact sound by floor coverings on a heavyweight reference floor

No. of test report: T1748-2

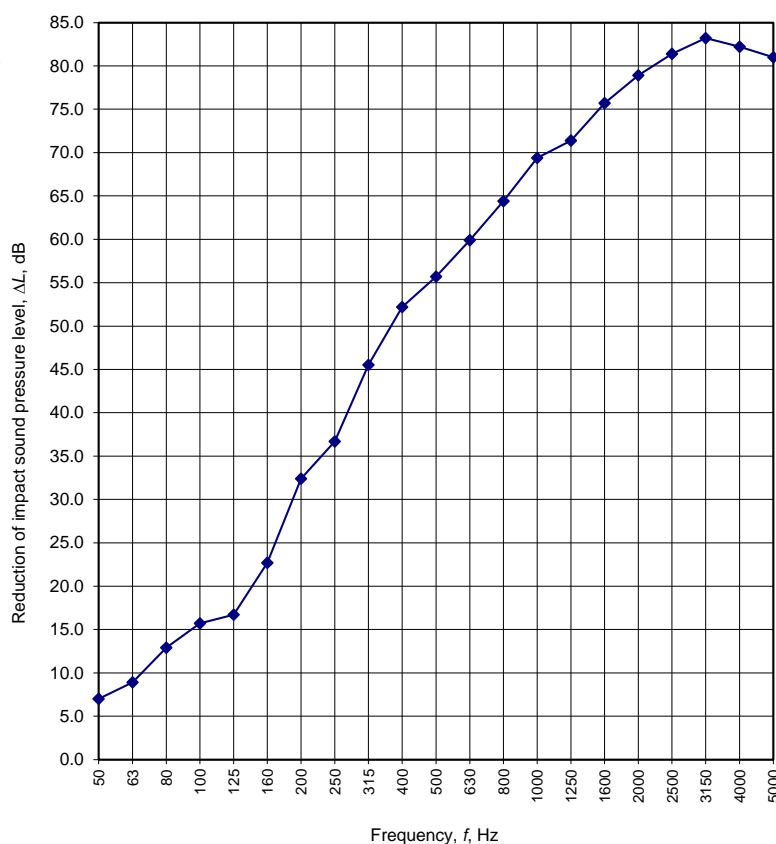
Frequency <i>f</i> Hz	$L_{n,0}$ One-third octave dB	ΔL One-third octave dB
50	54.4	7.0
63	50.0	8.9
80	56.8	12.9
100	63.7	15.7
125	65.8	16.7
160	66.1	22.7
200	68.7	32.4
250	72.1	36.7
315	71.3	45.5
400	69.9	52.2
500	74.2	55.7
630	72.0	59.9
800	71.2	64.4
1000	71.3	69.4
1250	71.3	71.4
1600	71.1	75.7
2000	72.0	78.9
2500	72.5	81.4
3150	72.6	83.2
4000	71.1	82.2
5000	68.2	81.0

Notes: #N/A = Value not available. **Bold** values are used to calculate ΔL_w .
 < indicates that the true value is lower.
 $L_{n,0}$ are the bare floor impact sound levels.

$\Delta L_w = 41$ dB $C_{I,\Delta} = 14$ dB $C_{I,r} = 2$ dB $C_{1,50-2500} = 3$ dB

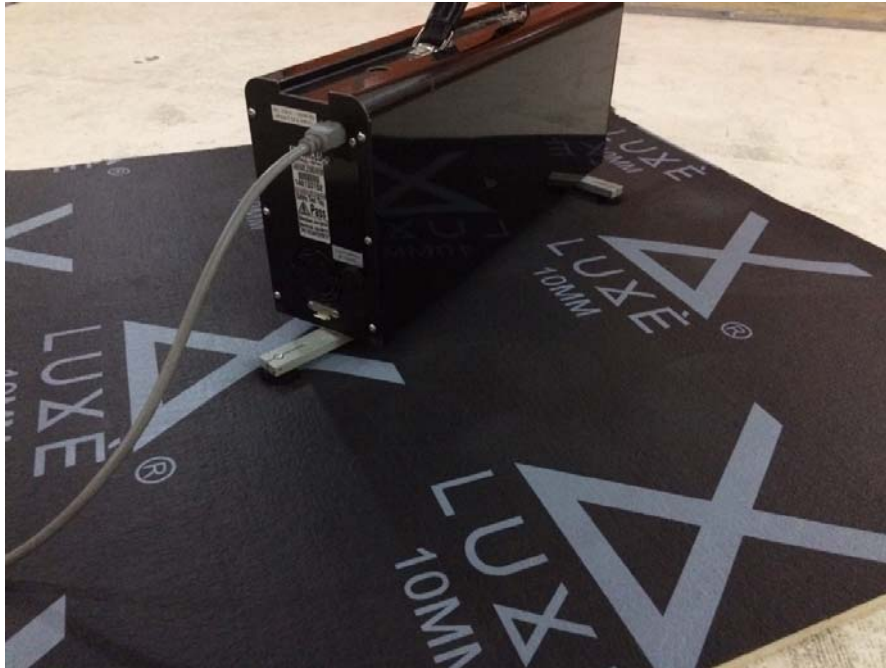
Figure 1: Tapping machine on sample in position 1

The BK3204 tapping machine is placed sequentially in four different positions on the floor. The impact sound pressure level is measured in the room below the floor, using a rotating microphone, in third octave frequency bands. The impact sound pressure levels are normalized against the room absorption. The room absorption is calculated from the reverberation time and room volume. The reverberation time is measured from the decay of a steady state sound field.

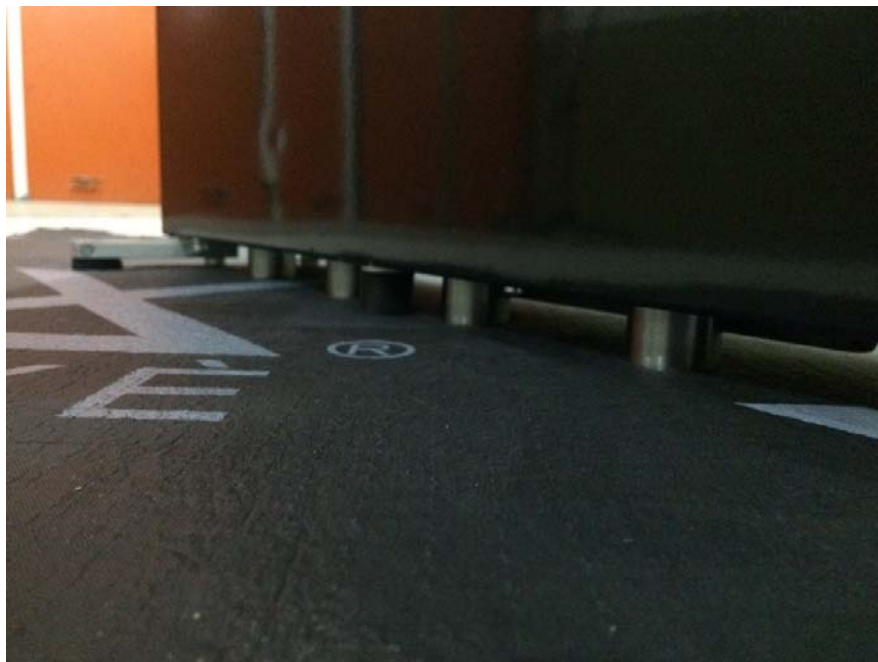
Figure 2: Tapping machine on sample in position 4

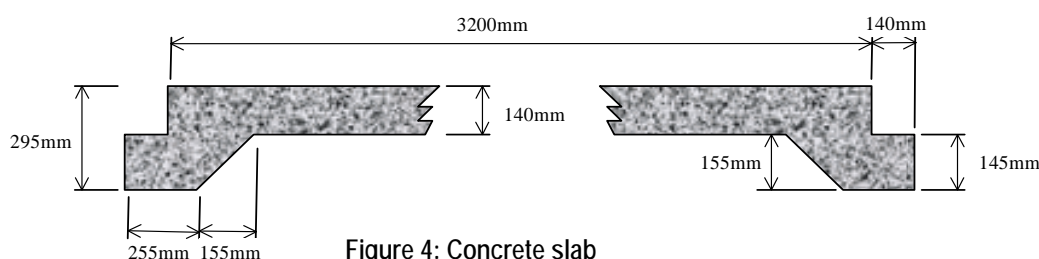
Figure 4: Concrete slab

Deviation from standard: The bare test floor used is of uniform thickness for an area of only 2.6m x 2.6m. The description of the bare test floor is given in the full report.
