**LABORATORY MEASUREMENT OF
THE REDUCTION OF
TRANSMITTED IMPACT SOUND OF
UNDERLAY
(ACCORDING TO ISO 10140-3)**

AUCKLAND UNISERVICES LIMITED
a wholly owned company of
THE UNIVERSITY OF AUCKLAND

Luxe Group Limited
PO Box 31815 Milford,
Auckland 0741
New Zealand
0508 663 3356

Date: 4th December 2017

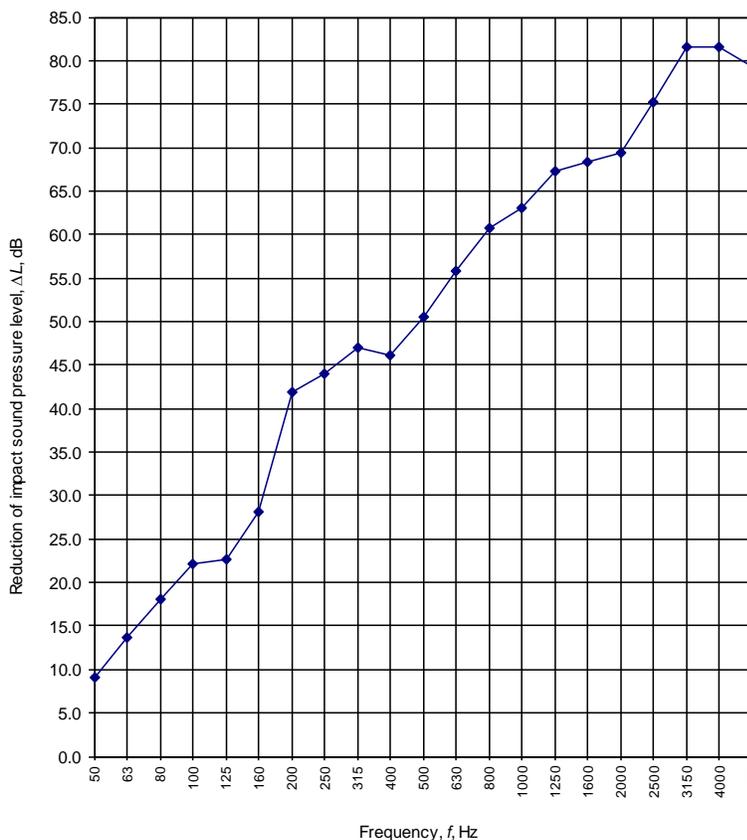
Frequency <i>f</i> Hz	<i>L</i> _{<i>n,0</i>} One-third octave dB	ΔL One-third octave dB
50	54.4	9.0
63	50.0	13.7
80	56.8	18.0
100	63.7	22.1
125	65.8	22.6
160	66.1	28.1
200	68.7	41.9
250	72.1	44.0
315	71.3	47.0
400	69.9	46.1
500	74.2	50.5
630	72.0	55.9
800	71.2	60.8
1000	71.3	63.1
1250	71.3	67.2
1600	71.1	68.3
2000	72.0	69.4
2500	72.5	75.3
3150	72.6	81.6
4000	71.1	81.5
5000	68.2	79.2

Notes: #NA = Value not available. **Bold** values are used to calculate ΔL_w .
 < indicates that the true value is lower.
*L*_{*n,0*} are the bare floor impact sound levels.

$\Delta L_w = 47$ dB

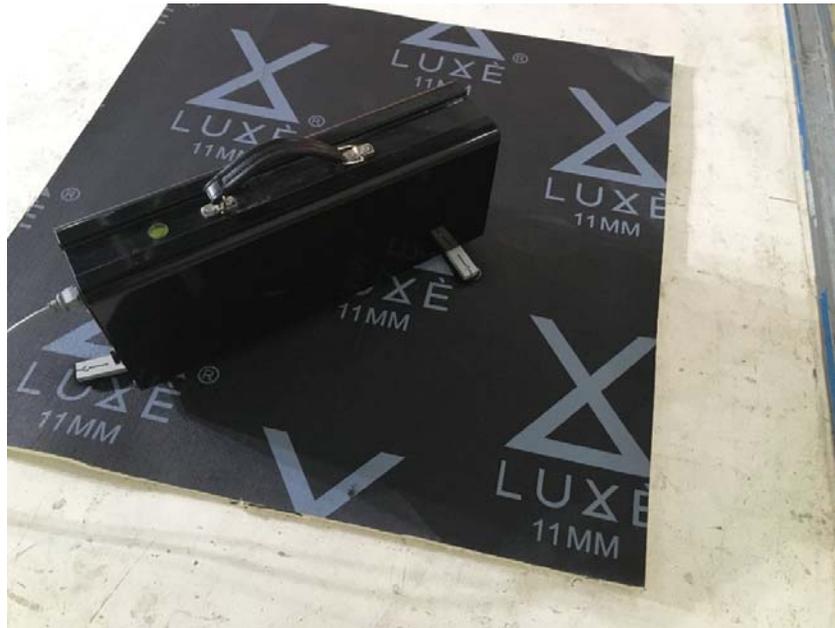
Figure 1: Tapping machine on sample in position 1

The BK3204 tapping machine is placed sequentially in four different positions on the floor. The impact sound pressure level is measured in the room below the floor, using a rotating microphone, in third octave frequency bands. The impact sound pressure levels are normalized against the room absorption. The room absorption is calculated from the reverberation time and room volume. The reverberation time is measured from the decay of a steady state sound field.

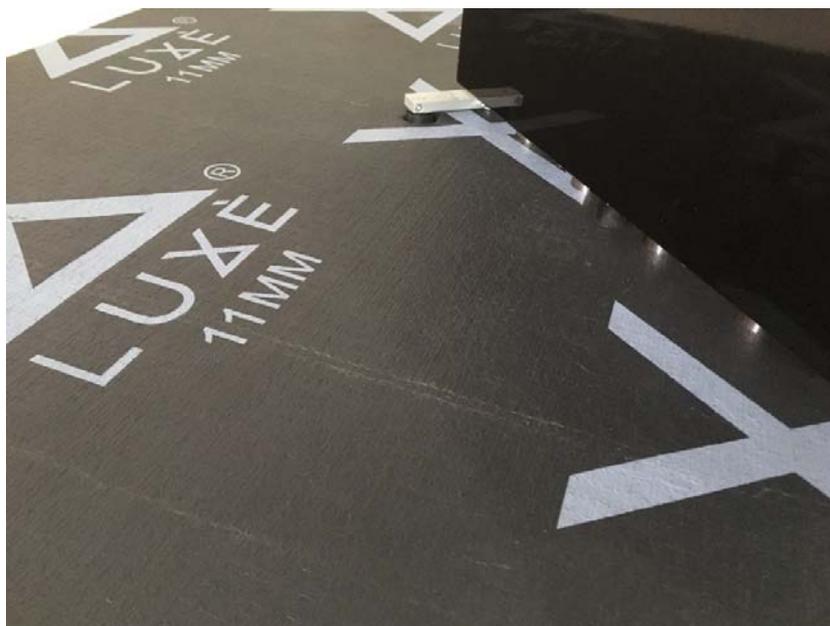
Figure 2: Tapping machine on sample in position 2

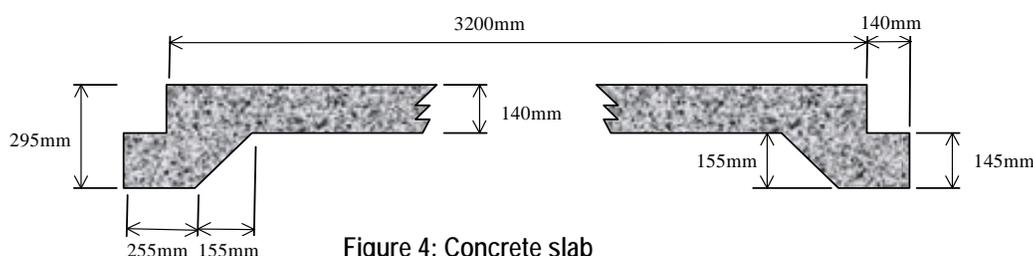
The floor/ceiling system under test is installed in the opening between the two large reverberation chambers – chambers B and A. These chambers are vibration isolated from each other which results in a structural discontinuity at the middle of the test opening. This gap is covered over by a wooden collar, which seals the gap and provides for ease of fixing of samples

Figure 4: Concrete slab

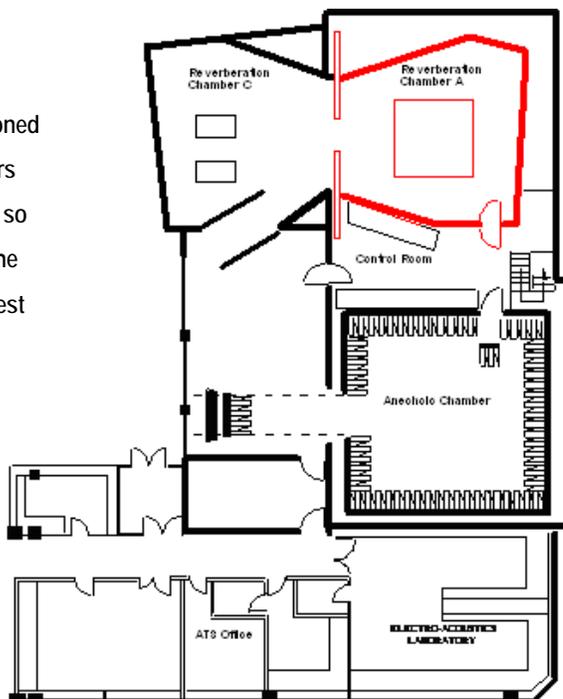
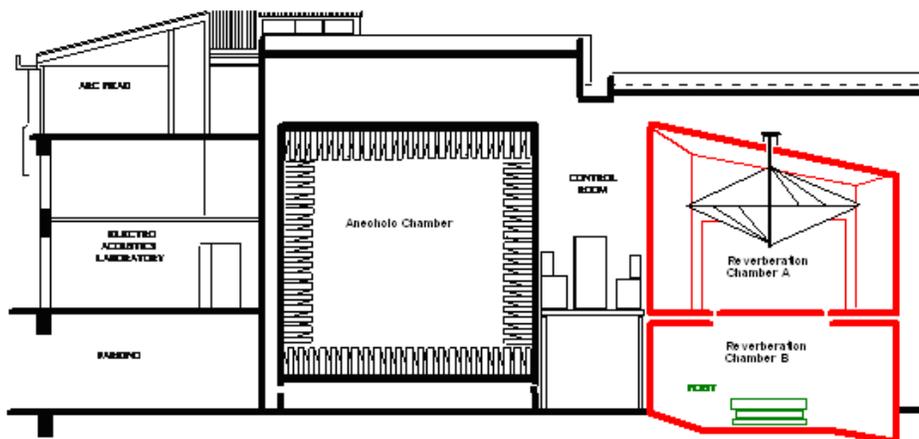
ANNEX D.
**DESCRIPTION OF REVERBERATION CHAMBERS AT
THE ACOUSTICS RESEARCH CENTRE**

There are three large interconnected reverberation chambers at the Acoustics Research Centre, two at ground level (Chambers C and A) and the third (Chamber B) below A.

All three reverberation chambers may be described as hexagonal prisms; each having 6 vertical sided walls, perpendicular to the floor. The roofs of chamber A and C are plane, but inclined at 12 degrees from horizontal. Chamber B has a plane, horizontal roof which is the floor of chamber A above it. The floor of chamber B is also horizontal, but has two angled sections at its north west and south east ends. The centre section is horizontal because a floor jack is installed there. The floor jack may be raised hydraulically to the ceiling of chamber B, the centre of which consists of a floor plug between the two chambers. This plug may be disconnected from chamber A and lowered down into chamber B, leaving a 3.2m x 3.2 m opening between the two chambers. This allows for the measurement of airborne and impact insulation of floor and roof elements.

The three Reverberation Chambers are linked by heavy steel doors and a removable Standard Industrial Floor Section which is removed and repositioned by a hydraulic hoist. The three chambers are vibration isolated from one another so that sound can only pass from one to the other via the intervening Test Wall or Test
