LABORATORY MEASUREMENT OF THE REDUCTION OF TRANSMITTED IMPACT SOUND OF CARPET UNDERLAY

Test report ID: T1806

LABORATORY MEASUREMENT OF THE REDUCTION OF TRANSMITTED IMPACT SOUND BY FLOOR COVERINGS ON A STANDARD FLOOR

Luxe Group Limited
PO Box 31815 Milford,
Auckland 0741, New Zealand

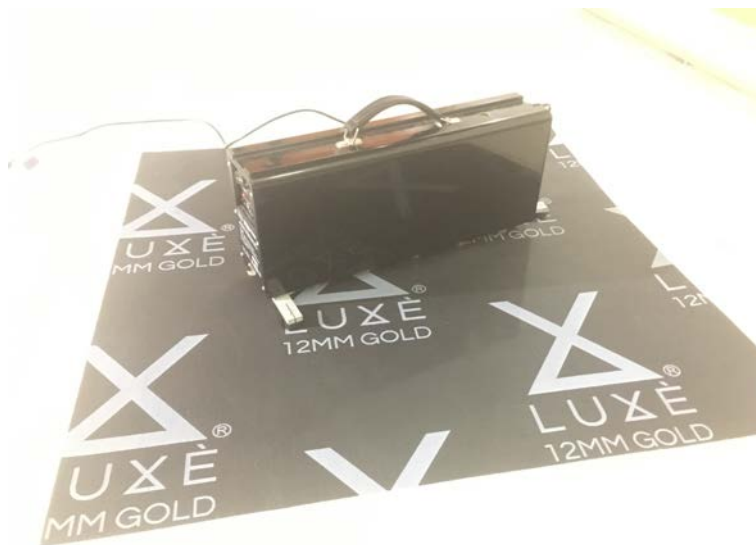
Figure 1.1: Underlay sample with tapping machine

Underlay: Luxe 12 mm Gold loose laid foam underlay only
 Concrete Slab
 Weight = 1,750g
 Dimensions = 1000 x 1000 mm
 Measured approximate volumetric density = 145.8kg/m³

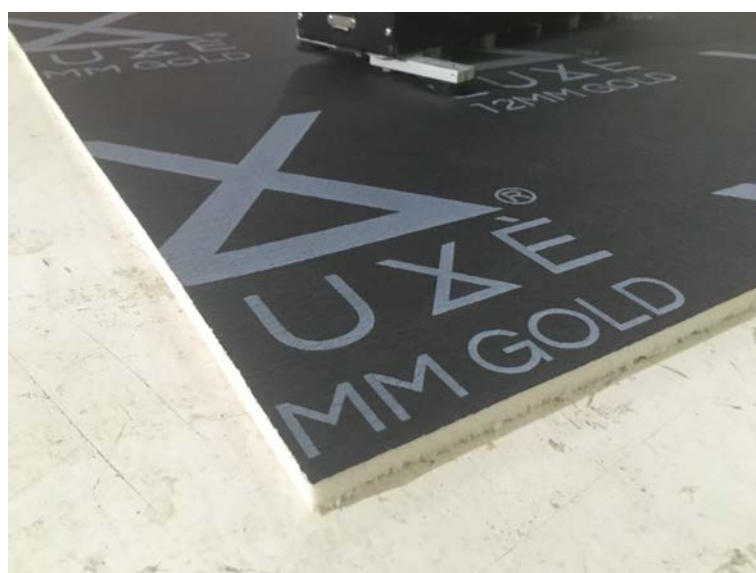
Figure 1.2: Underlay sample on chamber floor

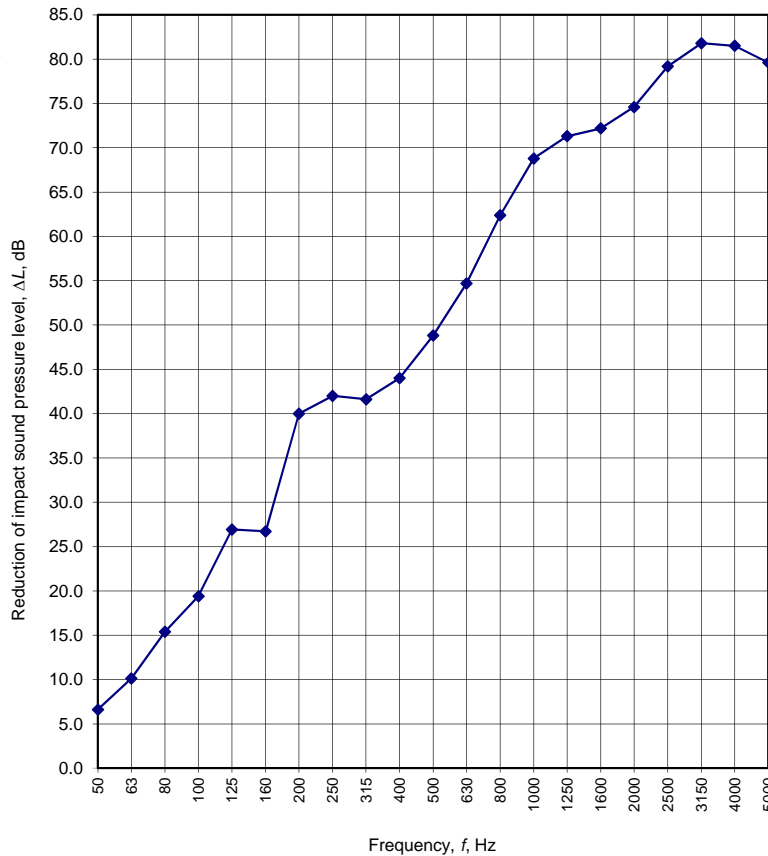
Frequency <i>f</i> Hz	<i>L</i> _{<i>n,0</i>} One-third octave dB	ΔL One-third octave dB
50	49.4	6.6
63	49.6	10.1
80	63.4	15.4
100	65.6	19.4
125	70.0	26.9
160	68.8	26.7
200	69.7	40.0
250	72.1	42.0
315	72.7	41.6
400	71.5	44.0
500	73.5	48.8
630	73.0	54.7
800	72.6	62.4
1000	73.1	68.8
1250	72.8	71.3
1600	71.6	72.2
2000	72.3	74.6
2500	73.1	79.2
3150	73.2	81.8
4000	71.9	81.5
5000	69.2	79.6

Notes: #N/A = Value not available. **Bold** values are used to calculate ΔL_w .
 < indicates that the true value is lower.
*L*_{*n,0*} are the bare floor impact sound levels.

$\Delta L_w = 47$ dB

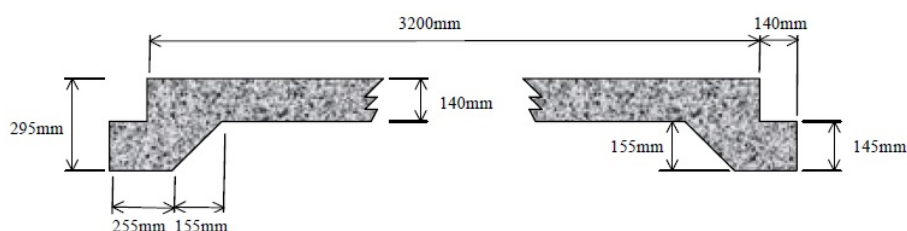
Figure 3.1: Floor/ceiling system

The floor covering is installed on a concrete floor plug that is positioned in the opening between two large reverberation chambers – chambers B and A. These chambers are vibration isolated from each other, which results in a structural discontinuity at the middle of the test opening. This gap is covered over by a wooden collar, which seals the gap and provides for ease of fixing of samples. The concrete floor plug is made of concrete reinforced with steel and is covered with a layer of hard resin. The dimensions of the floor plug are given in the following elevation diagram. If the floor covering is flexible, three samples to be tested are laid by the client following the techniques normally used in practice for that type of floor covering, with the constraint that the concrete floor plug be protected by a layer of thin self adhesive plastic tape if necessary.
