LABORATORY MEASUREMENT OF THE REDUCTION OF TRANSMITTED IMPACT SOUND OF AN UNDERLAY WITH NO CARPET

Test report ID: T2118-1

LABORATORY MEASUREMENT OF THE REDUCTION OF TRANSMITTED IMPACT SOUND BY FLOOR COVERINGS ON A STANDARD FLOOR

Brand name: Luxe Silk Memory Underlay

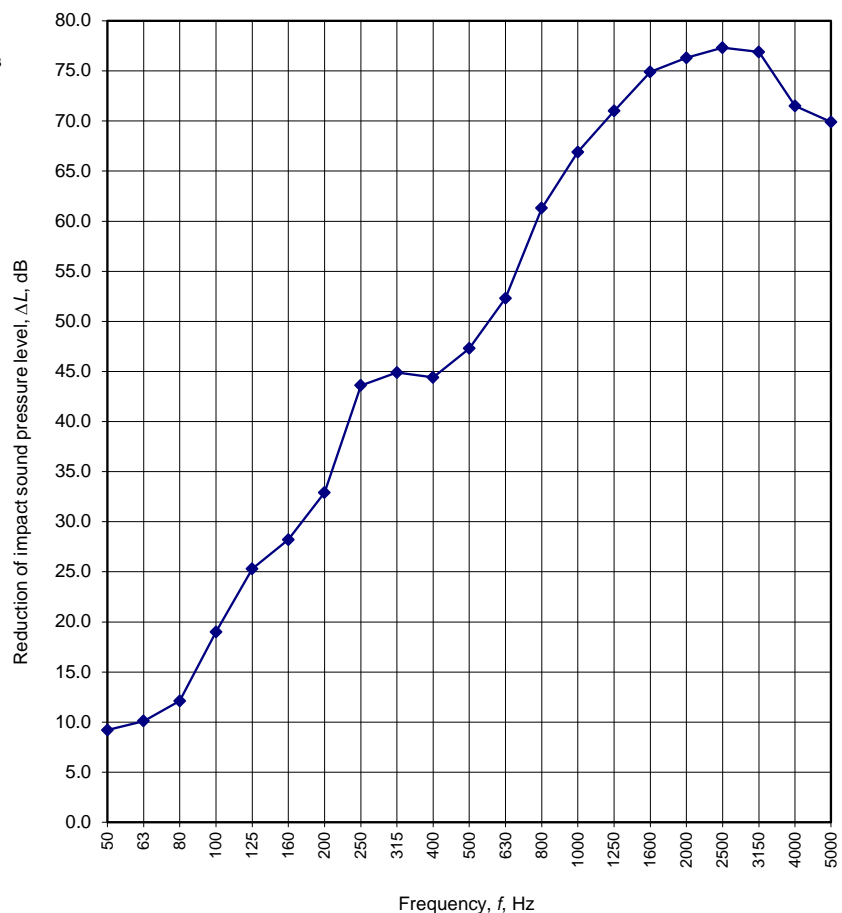
Frequency <i>f</i> Hz	<i>L</i> _{<i>n,o</i>} One-third octave dB	ΔL One-third octave dB
50	54.6	9.2
63	50.7	10.1
80	56.3	12.1
100	60.8	19.0
125	66.9	25.3
160	66.2	28.2
200	68.3	32.9
250	68.3	43.6
315	72.0	44.9
400	73.4	44.4
500	79.9	47.3
630	76.3	52.3
800	73.8	61.3
1000	72.8	66.9
1250	73.6	71.0
1600	79.5	74.9
2000	79.3	76.3
2500	76.6	77.3
3150	75.4	76.9
4000	71.8	71.5
5000	68.0	69.9

Notes: #N/A = Value not available. **Bold** values are used to calculate ΔL_w .
 < indicates that the true value is lower.
*L*_{*n,o*} are the bare floor impact sound levels.

Rating according to ISO 717-2:

$\Delta L_w = 46$ dB

The third octave band normalized impact sound pressure levels L_n are presented in both table and graph formats. Sometimes a highly reflective test sample means that the lower frequency

normalized impact sound pressure levels cannot be reliably measured; this is indicated by # N/A in the table of results. Additionally, sometimes the airborne transmission of sound through the floor or loud background noise affects the measurements resulting in only an upper threshold being found; this is indicated by a < sign preceding the tabulated results. Single figure ratings are also presented. The weighted normalized impact sound pressure level $L_{n,w}$, determined according to ISO 717-2, is presented along with a spectrum adaptation term C_l . $L_{n,w}$ is determined by fitting a reference curve to the third octave band normalized impact sound pressure levels L_n from 100Hz to 3150Hz, and gives a single figure determination of the sound levels which are transmitted through the floor from impacts (higher is worse). The spectrum adaptation term C_l is used to suggest the presence of high level peaks in the results over the frequency range 100Hz to 2500Hz, and may be added to $L_{n,w}$. For massive floors with effective coverings C_l will be about zero, for light timber floors C_l will be slightly positive, and for concrete floors with less effective covering C_l will range from -15 dB to 0dB. Another spectrum adaptation term $C_{l,50-2500}$, which covers the frequency range from 50Hz to 2500Hz, may also be presented if the low frequency levels are available. The impact insulation class (IIC) determined according ASTM E989 is also presented. This is determined by fitting a reference curve to the third octave band normalized impact sound pressure levels L_n from 100Hz to 3150Hz, but in a slightly different way to ISO 717-2. The impact insulation class measures the insulating abilities of the floor so that higher is better (contrary to $L_{n,w}$).

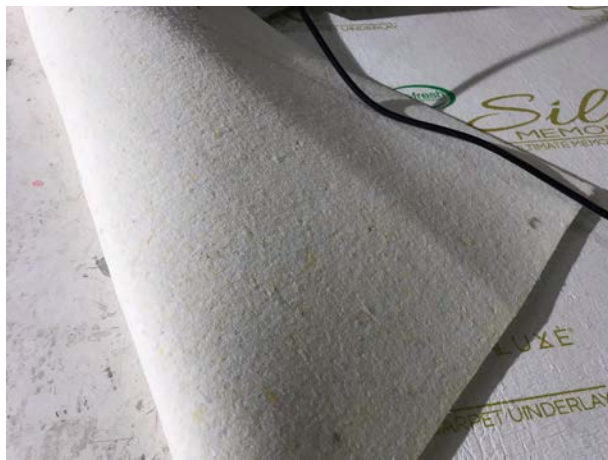
Figure 2.1: Installing Underlay

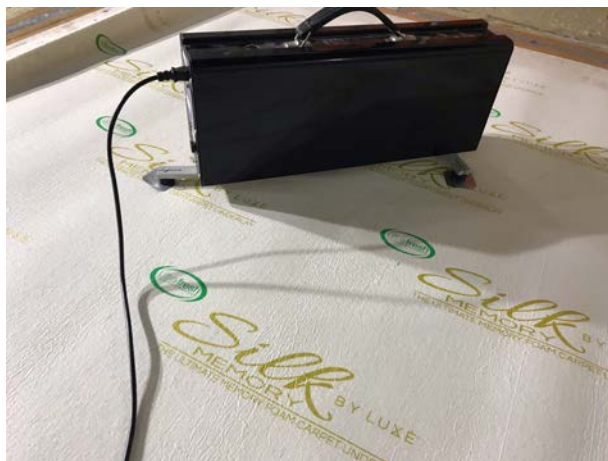
Figure 2.2: Underlay detail with tapping machine positioned in chamber

The normalized impact sound pressure levels are obtained in accordance with the recommendations of ISO standard 10140-3 “Measurements of impact sound insulation.” The BK3204 tapping machine is placed sequentially in four different positions on the floor. The impact sound pressure level is measured in the room below the floor, using a rotating microphone, in third octave frequency bands. The impact sound pressure levels are normalized against the room absorption. The room absorption is calculated from the reverberation time and room volume. The reverberation time is measured from the decay of a steady state sound field. Corrections are applied, where necessary, for airborne sound transmission and background noise. The airborne sound transmission is determined using a loudspeaker and the microphone.
