LUXURY VINYL TILE (LVT) WET ROOMS WATERSPLASH INSTALLATION SYSTEM ALTERNATIVE SOLUTION

- E3/AS1 BUILDING CODE- INTERNAL MOISTURE FOR FINISHES TO FLOORS: BATHROOMS

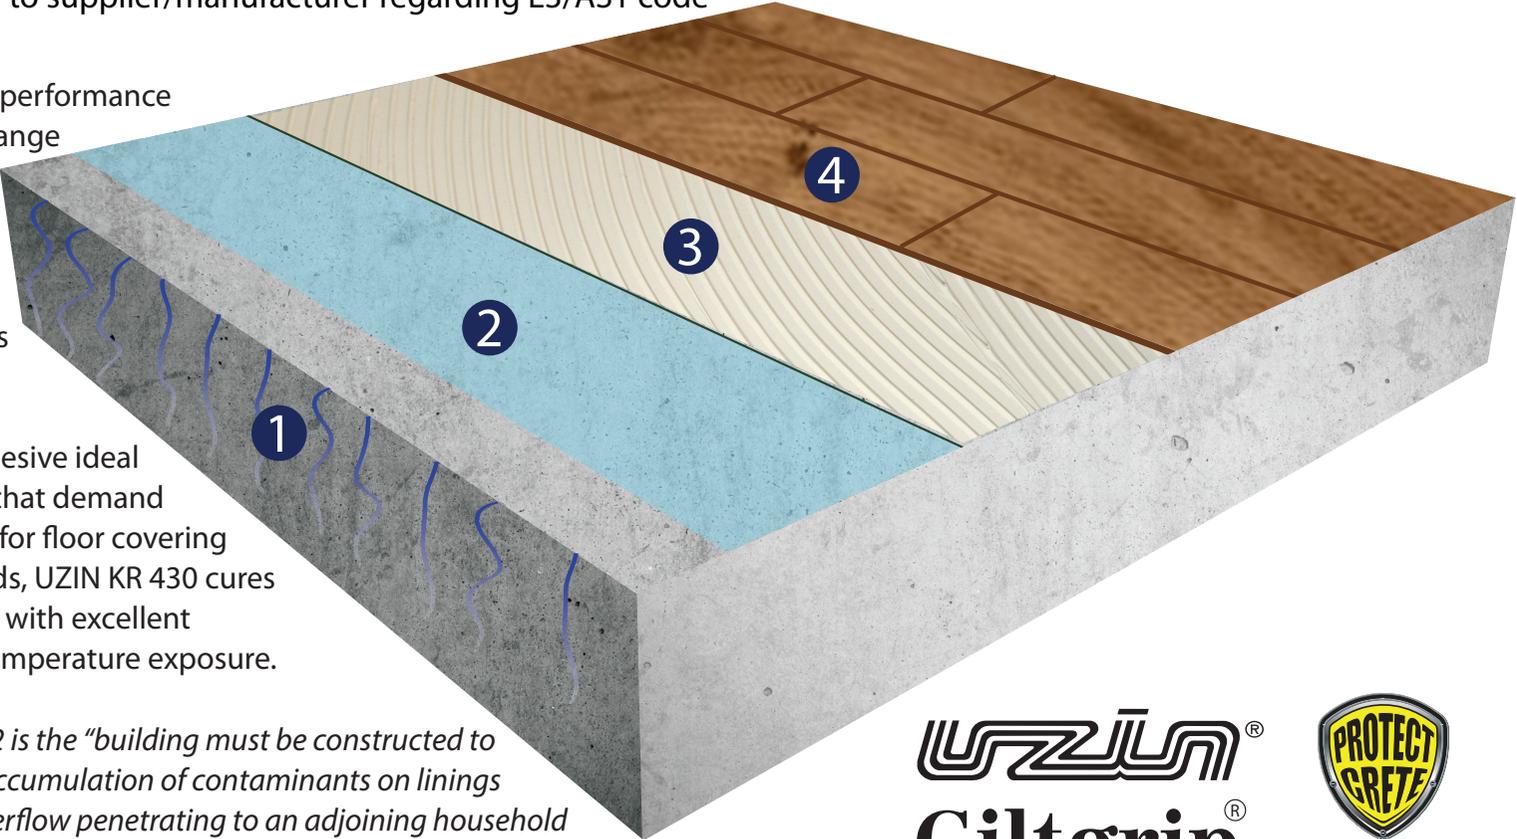
- 1 Concrete substrate treated with Protect Crete Densi-Proof X200 (Optional.)
- 2 Subfloor Preparation Systems (Optional site specific as required.)
Subfloor primed with Uzin PE280 (Non-porous) or Uzin PE520 (Porous)
OPTION 1.) Uzin NC160 or NC170 Levelling Compound
OPTION 2.) Uzin NC888 feather Finish
- 3 **ADHESIVE OPTION 1:** UZIN KE68T 1- Component Hybrid Adhesive
ADHESIVE OPTION 2: UZIN KR430 2-Part Urethane Adhesive
- 4 Luxury Vinyl Tile (LVT) as Specified: Refer to supplier/manufacturer regarding E3/AS1 code compliance.
